Reservoir Embankment Investigation & Stabilisation

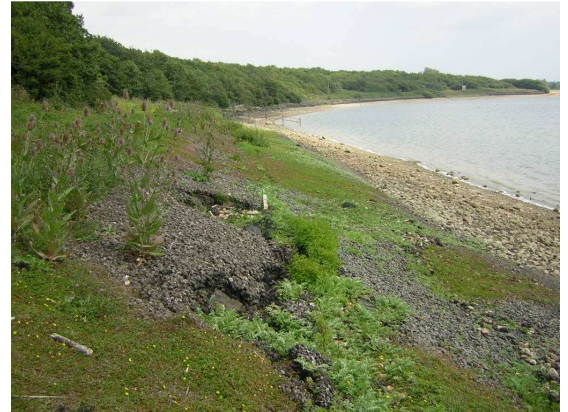
A recent walkover survey and mapping exercise identified many features that were indicative of slope instability, notably lateral ridges and tension cracks. The most well-defined were located in the centre of the bank where the gradient was steepest, and ties in with the instability identified from the historic aerial photographs.

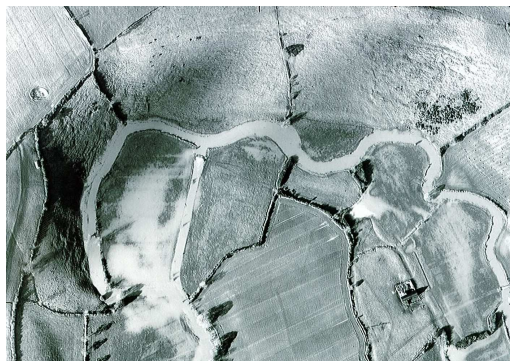
A hydrographic survey was undertaken to map the reservoir bed. An 'echo sounding' plot identified 'bulge' features and undulated ground that may be indicative of slope instability. These features were mapped and overlaid using GIS, demonstrating that the most significant 'bulges' were in the central and western parts of the site, although undulating ground was also observed along the entire length of the slope.

Boreholes up to 20m bgl were drilled with cable percussive, flight-auger and windowless sampler equipment with installation of standpipe piezometers and inclinometers. Inspection of undisturbed samples identified pre-existing slip surfaces, indicative of historical slope failures.

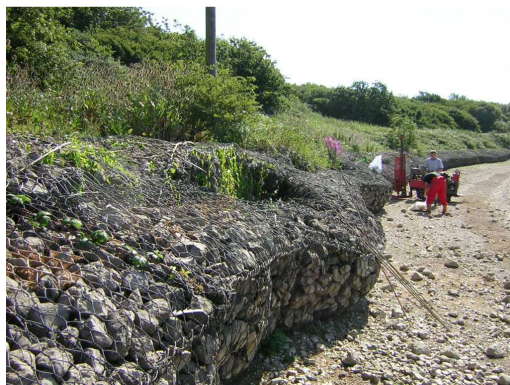
Computer based circular slip analyses were used to assess the stability of the slope under various groundwater and reservoir level scenarios; this demonstrated continuing instability and risk from deep seated and shallow failure.

- Repair of the shoreline with new gabion walls.
- Introduction of bioengineered structures to absorb some wave energy on the banks, provide support to soils, increase wildlife habitats and screen sections of the gabion wall from view.
- Introduction of a 40m long floating island pontoon to further reduce the impact from wind and wave action on the banks.

Detailed designs and tenders have also been sought and trials along the foreshore are expected in the near future. Monitoring of inclinometer wells across the site is ongoing.
