Slope Investigation Tonbridge Castle, Kent

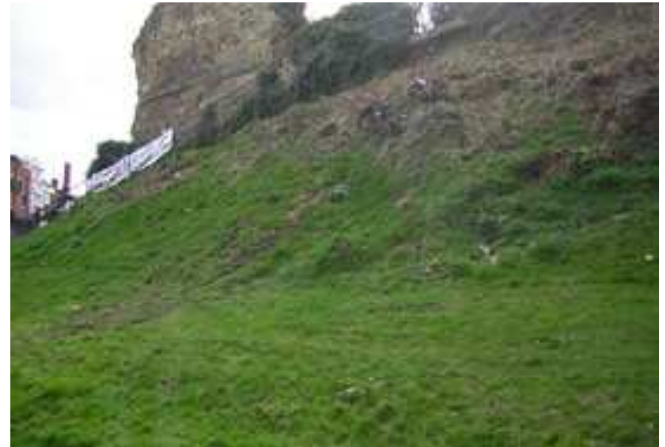
The movement was noted on the eastern limb of the outer keep, which comprises a 6 to 9m high embankment topped to the south by the remains of the outer castle wall. A tarmac footpath runs along the crest to the north, but steps down alongside the outer wall as it approaches the river to the south.

The analysis indicated that without remedial works the slope would continue to fail, principally centred around the path at the top of the embankment. Given the historical importance of the site, the remedial design would need to be carefully managed to avoid any damage to the existing foundations of the castle walls. Various remedial measures were proposed to achieve both the local and overall long-term slope stability. These included soil nailing or regrading the existing slopes together with soil reinforcement by use of gabion walls under the footpath.

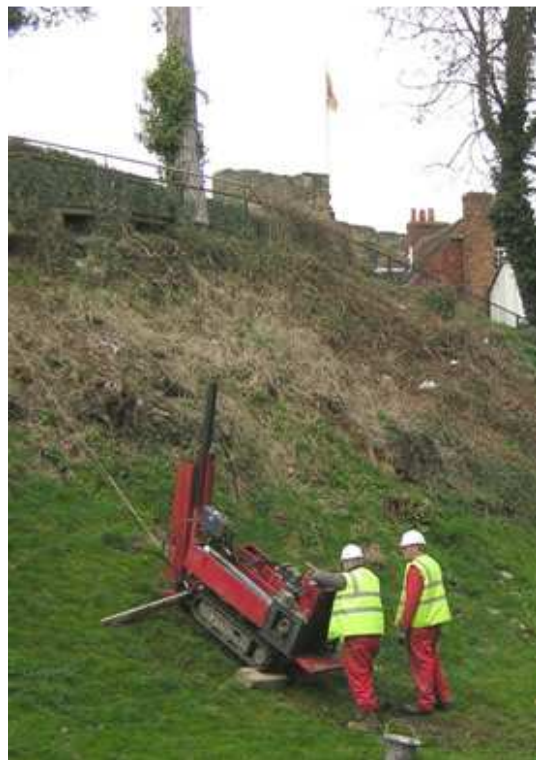
Southern Testing designed and undertook a detailed ground investigation, which included several restricted access boreholes, installation of slip indicators and a series of DPL dynamic penetration tests along the crest of the embankment. Soil conditions encountered comprised made ground of sands and clays, with natural soil at depth. No groundwater was encountered. Field monitoring results indicated that the slope was experiencing quite shallow landslip, but no significant movement had been recorded at lower depths.
