Slope Stability Investigation

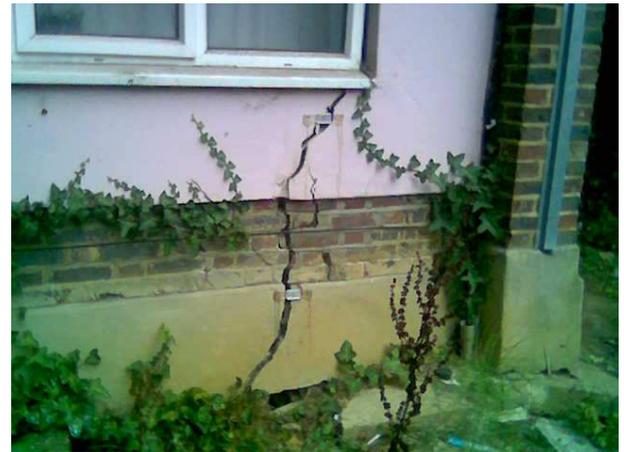
The site, located in southeast London, comprised a 5-storey block of flats. Significant movement had occurred on the eastern flank wall. The property overlooked sloping gardens and areas that were overgrown and vegetated with trees. Less significant movements were also noted elsewhere in the form of minor cracking of brickwork.

The site was located close to the junction of the Claygate Beds and the underlying London Clay. Slopes fell away quite abruptly at around 18-20° and presented challenges for access with ground investigation plant and equipment.

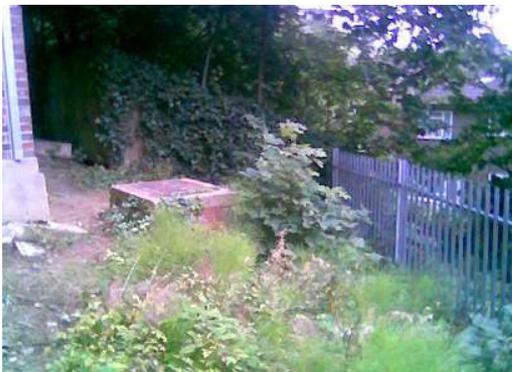
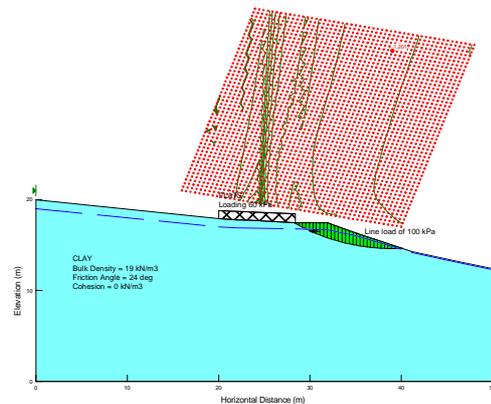
Boreholes were drilled in the slipped area with installation of slip indicators and inclinometers to monitor slope movement, and standpipe piezometers to monitor groundwater conditions. The soils encountered typically comprised very high strength London Clay with shear surfaces noted at depths of between 2.5-3.7m. Stability analysis was undertaken for the “original condition” assuming a first time slide condition under various assumed piezometric conditions to establish the sensitivity of the slopes to a fluctuating water table condition.

The second model analysed considered the “current condition” which assumed that residual shear strength soil conditions existed within the upper 4m. The analysis indicated highly marginal and/or unsatisfactory factors of safety for both soil models and recommendations were made for remedial measures.

Various remedial options were considered and integrated into an overall structural remedial design. These included:

- Drainage of the slopes, together with regrading of the slopes to reduced angles.
- Soil nailing with / without slope drainage.
- Contiguous bored pile wall with or without drainage of the slope and with/without tensioned ground anchors.
- A system of spaced piles with or without ground anchors and no drainage
- Ongoing monitoring of instrumentation
