Gas Works Remediation for Mixed-Use Development

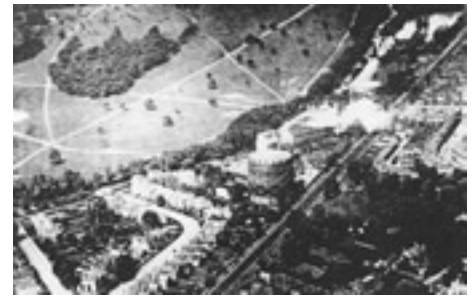
Figure 1 – Gas Works Early

The site, which extends to an area of approximately 2 hectares, encompasses the entire former Hampton Court Gas Works site, which was used for gas production from 1852 and closed in the mid 1970's (Figure 1 & 2). Historical studies showed the gas works were complex and contained up to five Gas Holders as well as range of underground and production structures. Subsequently part of the site was used as an Electricity Depot. Thereafter the majority of the site then comprised a builders merchant (approx 1.37ha), with the remaining area redeveloped with an office building and car park in the mid 1970's (approx 0.51ha), with one area of overgrown waste ground remaining in one corner (0.19ha).

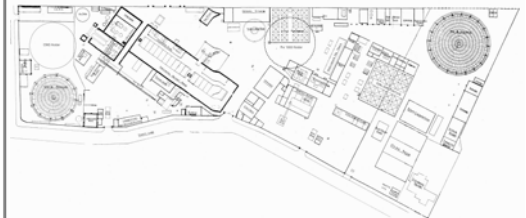
Figure 2 – Gas Works Layout

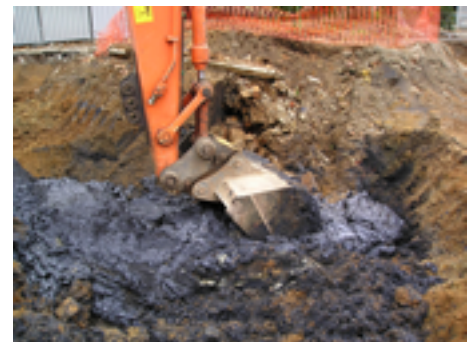
Figure 3 – Excavation of Tar Tank Structure

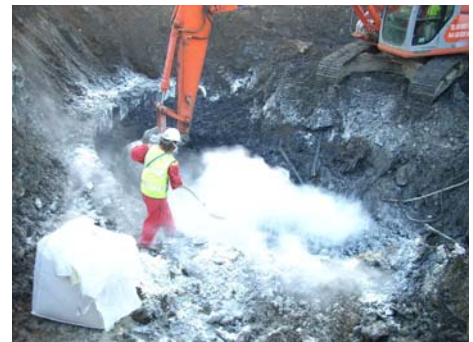
Figure 4 – Stabilisation to aid Excavation

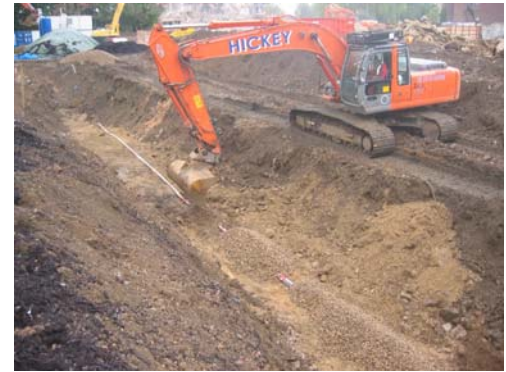
Figure 8 – In Situ Biopile Collector Pipework

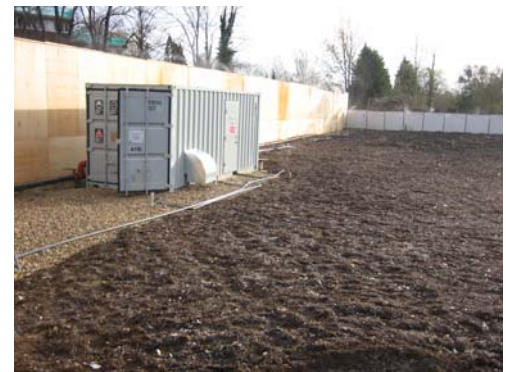
Figure 9 – Below ground (In-situ) Biopile

The approach for the general site area entailed a "blanket" excavation, sorting and onsite treatment of all materials within the upper 3m. In-situ treatment work stages comprised the installation of treatment process pipes within excavation strips, prior to replacing soils for treatment (Figure 9). These are connected to the containerised treatment plant (Figure 10). Amendments are added with the soils to allow optimal conditions to be created for degradation of contaminants. During the 20 week treatment the soil is occasionally decompacted to aid the transfer of air through the soil. Biogenie also provided a system for collection and treatment of waters encountered in excavation, prior to discharge under consent to foul sewer. At the time of writing preparations are being made for treatment of pile arising from across the northern part of site (gas holders) using ex-situ bioremediation located on-top of the former in-situ biopiles.

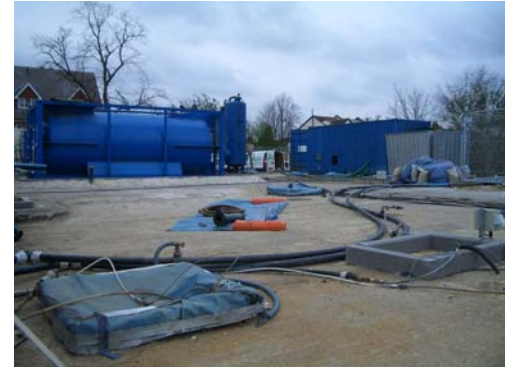
Figure 10 – Insitu Treatment Gasholders

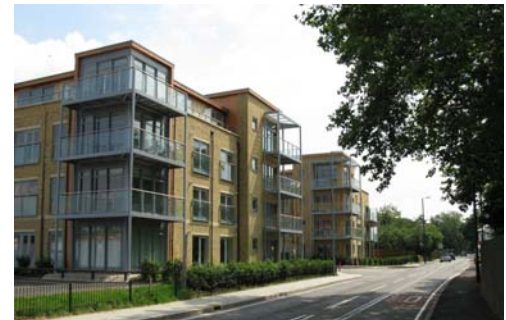
Figure 11 – Phase 1 Complete.
