# Gas Works Remediation for Residential Development

The remediation of Tunbridge Wells Gas Works to a standard suitable for residential development was always going to be a challenging exercise. To have achieved this in the context of a very commercially driven timeframe, within a strict regulatory regime, whilst keeping to budget required a highly innovative design and an unprecedented degree of partnering between all stakeholders. This complex project resulted in successful treatment and re-use onsite of over 99% of the approximately 40,000 tonnes of contaminated soil processed. From initial investigation to first residential occupations was a period of less than 16 months. The projects undoubted success is the product of intensive activity by all involved and perhaps unusually leaves in its wake a real sense of pride, satisfaction, and closer relations for those who collaborated.

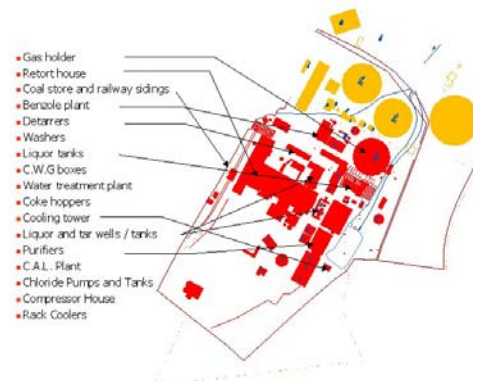
Figure 1 - Former Gas Works Layout

The site which extends to approximately 4 hectares had previously been used for gas production from the early 1890's until mid 1970 (Figure 1), and then subsequently as a Transco Depot. SecondSite undertook ground investigations in early 2000 to assess the extent of contamination and associated environmental liabilities. Remediation as part of a risk reduction exercise was undertaken in 2002 with identified areas of highly contaminated soil excavated as part of a "dig and dump" strategy and removed from site to landfill. The brief only met a specified sit end use of "securely fenced vacant land" and residual elevated levels of hydrocarbon contamination where reported to still be present.

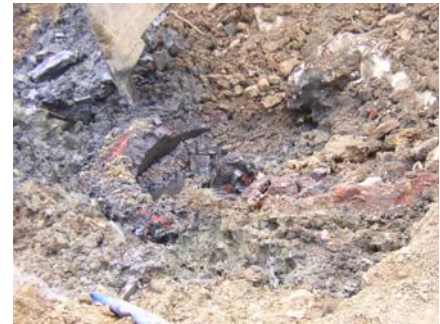
Figure 2 - Excavation of Tar Tank Structure

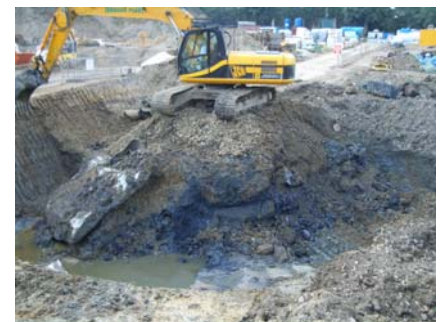
Figure 3 - Zonal Excavation and Remediation

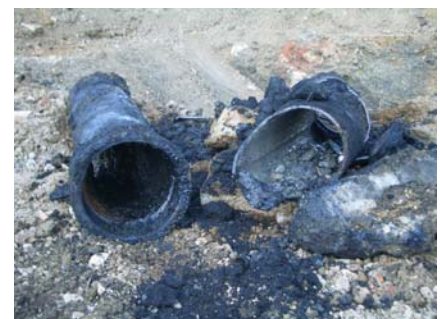
Figure 4 - Contamination around Culvert

buildings, including a gasholder, remained intact below ground. The soils were generally found to be contaminated with PAH's, TPH, and BTEX compounds associated with town gas production. Significant hydrocarbon contamination was identified along the boundary with the remaining Gas Holder Station. A shallow compacted clay wall had been constructed as part of the earlier risk reduction exercise along part of this boundary. However, investigation indicated this to be ineffective and saturated with contaminants migrating from the adjoining site.

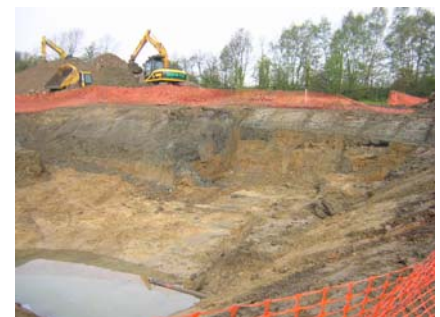
Figure 5 - Remediated Zone

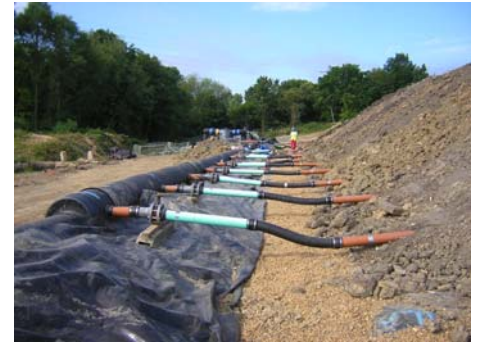
Figure 6 – Bio-Pile Collector Pipework

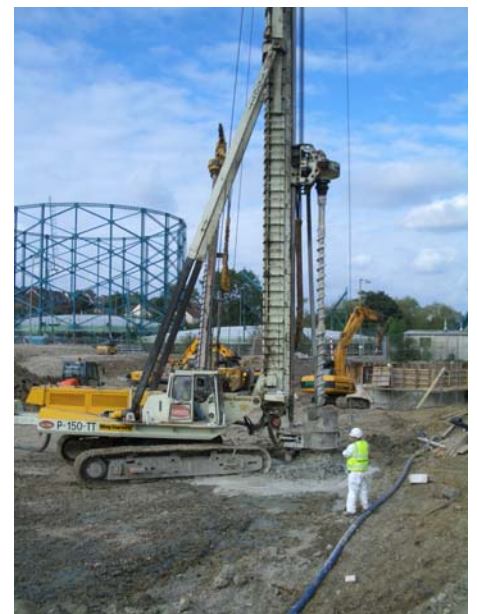
Figure 7 – Reactive Barrier Wall Installation

To mitigate against risks of both onsite and offsite contaminant migration, Specialist Remediation Contractor "May Gurney" was appointed to design and implement "in ground barriers". To prevent recontamination of remediated soils and reduce the risks of future onsite migration of contaminants from beneath the adjoining gas holder station, a non-reactive / impermeable "in ground barrier" was constructed to a depth of between 9.5 m and 12.5m along the length of the northern site boundary (approximately 100m) keying into the clean underlying Wadhurst Clay.

The in ground barriers have now been in operation for nearly 10 months. Ground water monitoring wells located on either side, along the length of the barriers, are indicating the system to be operating within the design criteria.

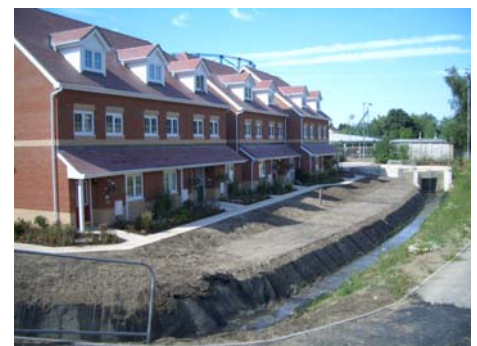
Figure 8 – Phase 2a Complete. Barrier wall beneath footpath and new stream channel

In addition, the new stream channel has been designed to incorporate a hydrocarbon resistant liner, puddle clay surround and erosion mat. An engineered site surfacing will be provided within all garden and open landscaped areas to provide positive drainage for infiltration in a fully clean environment.
