Gas Works Remediation for Residential Development

Synopsis

Introduction

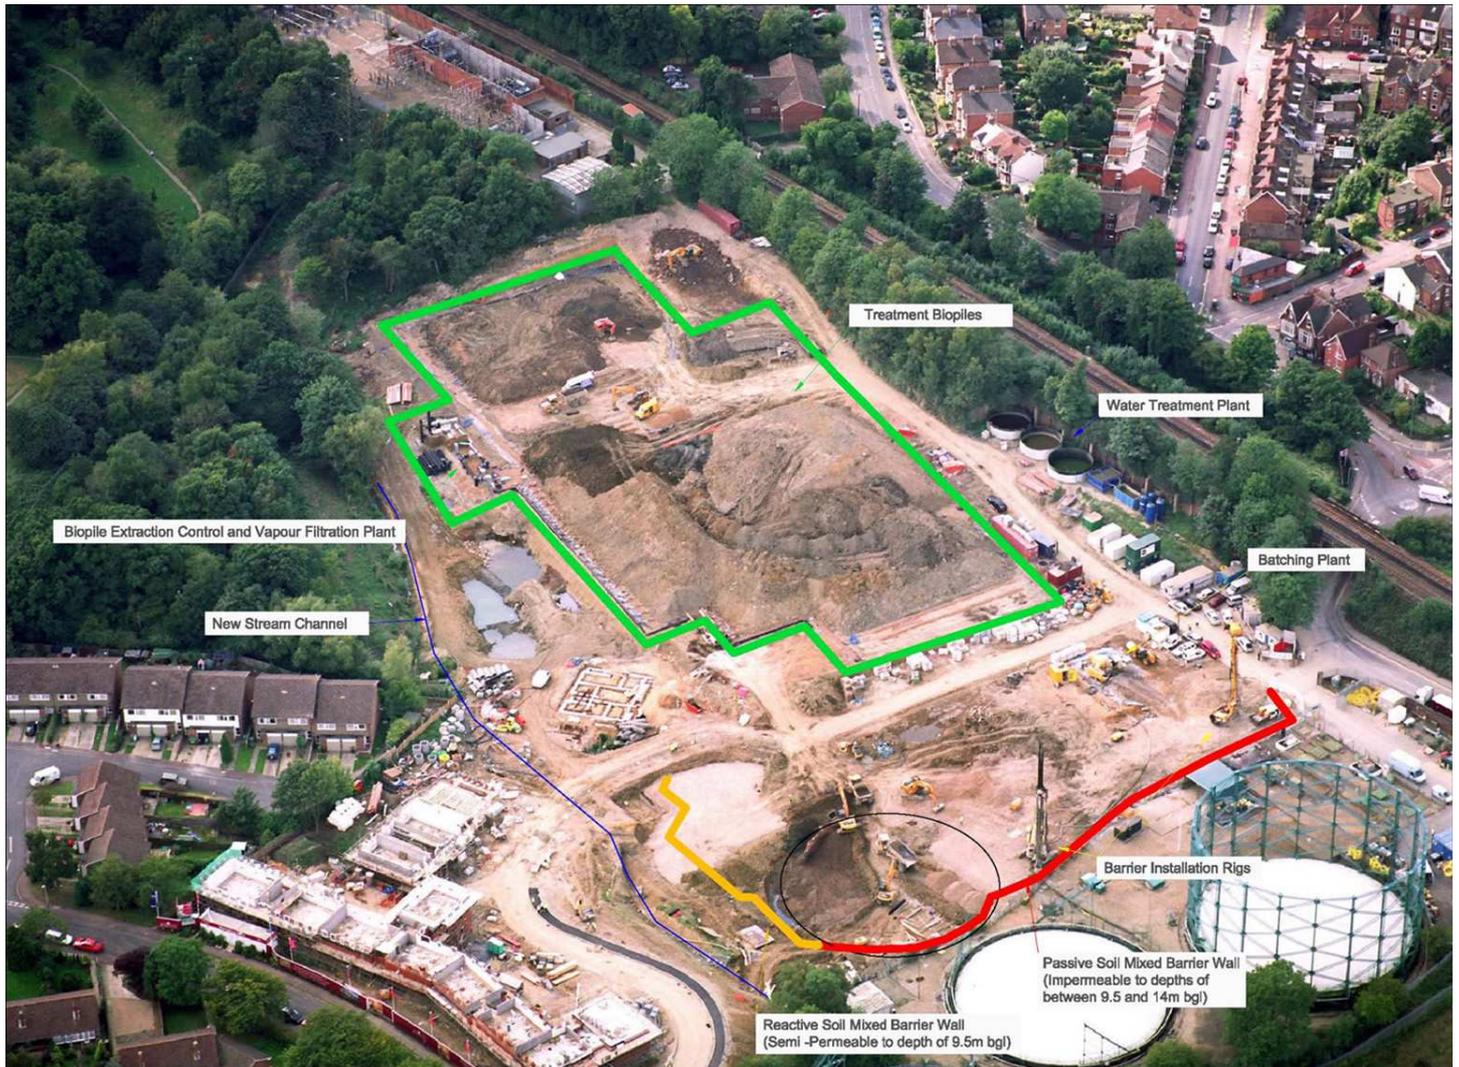
The site extends to approximately 4 hectares and had been used previously for gas production from the early 1890s until mid-1970 (Figure 1), and then subsequently as a Transco Depot. SecondSite undertook ground investigations in early 2000 to assess the extent of contamination and associated environmental liabilities. Remediation was undertaken in 2002 as part of a risk reduction exercise. Some areas of highly contaminated soil were excavated and removed from site to landfill as part of a “dig and dump” strategy. The remediation only met a specified site end use of “securely fenced vacant land” and residual elevated levels of hydrocarbon contamination were reported to be present still.

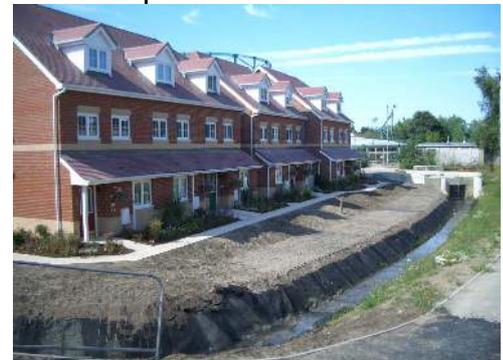
Figure 10 - Phase 2a Complete. Barrier wall beneath footpath and new stream channel

In addition, a new stream channel was designed to incorporate a hydrocarbon resistant liner, by utilising a puddle clay surround and an erosion mat. An engineered site surfacing is proposed for all garden and open landscaped areas to provide positive drainage for infiltration in a fully clean environment.
