## Reservoir Embankment – Investigation, Monitoring and Stabilisation

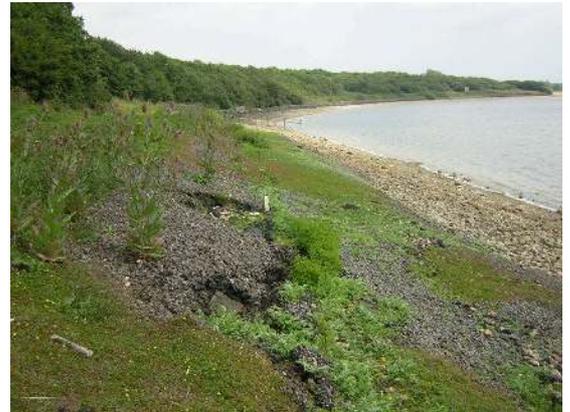
A recent walkover survey and mapping exercise identified many features that were indicative of slope instability, notably lateral ridges and tension cracks. The most well-defined were located in the centre of the bank where the gradient was steepest, and ties in with the instability identified from the historic aerial photographs.
