Slope Investigation - Tonbridge Castle, Kent

We were employed by Tonbridge and Malling Council to investigate a portion of the curtain wall embankment around Tonbridge Castle, where evidence of landslip had been observed.

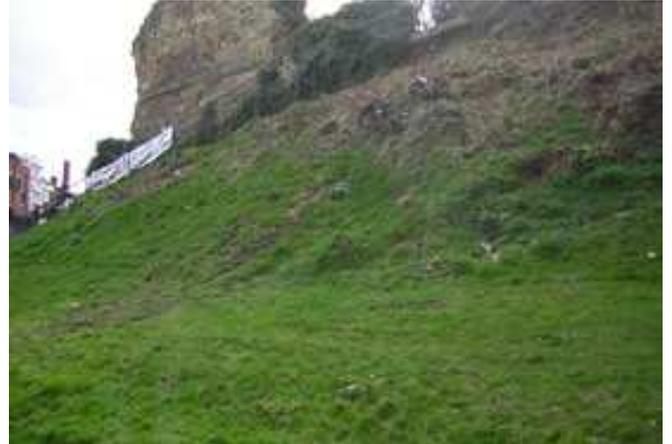
The embankment slopes stand at about 40°, but slip scars were visible just below the footpath and stretched about 30m along the crest of the embankment. Downslope there are several lengths (up to 12m) of toe bulging, with slumping and sloughing of materials, which had result in localised steeper slopes of over 50°.

The analysis indicated that without remedial works the slope would continue to fail, principally centred around the path at the top of the embankment. Given the historical importance of the site, the remedial design would need to be managed carefully to avoid any damage to the existing foundations of the castle walls. Various remedial measures were proposed to achieve both the local and overall long-term slope stability. These included soil nailing or regrading the existing slopes together with soil reinforcement by use of gabion walls under the footpath.

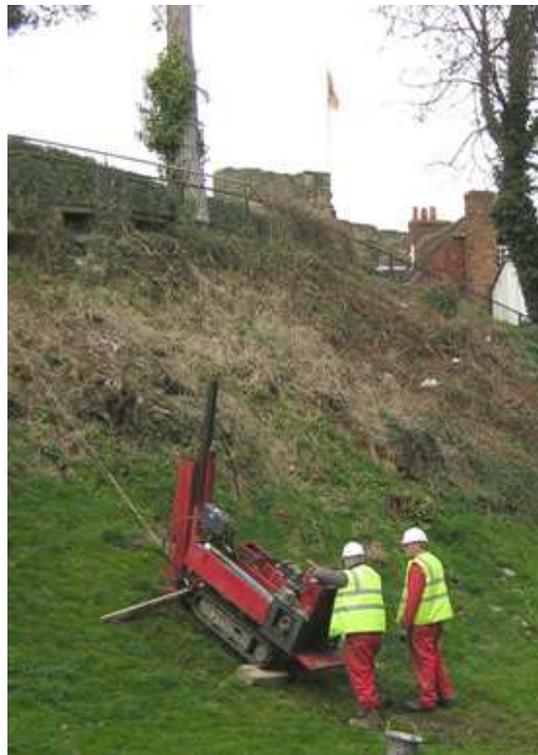
We designed and undertook a detailed ground investigation, which included several restricted access boreholes, installation of slip indicators and a series of DPL dynamic penetration tests along the crest of the embankment. Soil conditions encountered comprised made ground of sands and clays, with natural soil at depth. No groundwater was encountered. Field monitoring results indicated that the slope was experiencing quite shallow landslip, but no significant movement had been recorded at lower depths.
